Using Sea Turtle Carcasses to Assess the Conservation Potential of a Turtle Excluder Dredge

Development of Turtle Excluder Dredge

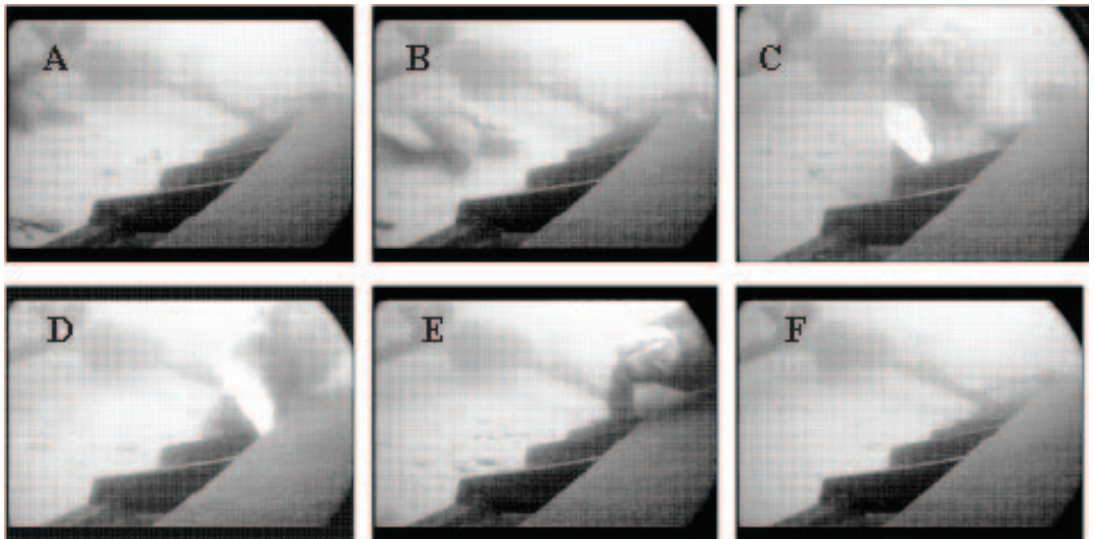
FIGURE 3.—Photographic sequence of a loggerhead sea turtle carcass encountering the Cfarm turtle excluder dredge: (A)–(B) the carcass first passes under the bale, then contacts the forward cutting bar, (C) gets deflected by the closely spaced struts, (D)–(E) is guided over the dredge frame, and (F) passes out of the view of the dredge-mounted video camera.

Nine interactions between a loggerhead carcass and the modified dredge were documented on the video recordings (Table 2; Figure 3). Two carcasses went over the dredge bale, while seven went underneath the bale. Two of the carcasses that went under the bale hit

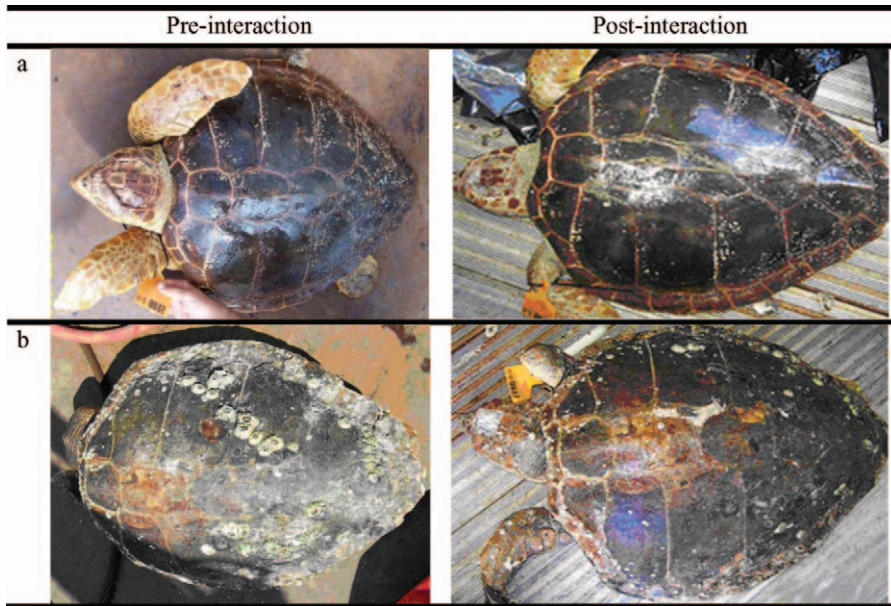
FIGURE 4.—Postinteraction carcass damage: (a) most loggerhead carcasses showed little or no damage after interacting with the turtle excluder dredge; (b) the most severe damage involved chips in the carapace scutes. Note that in both cases the damage to the head occurred during necropsy.

the hard rubber bale wheels and were hung up for a few seconds before passing the bale (one over and one under) and going over the dredge frame. In all nine interactions, the carcasses hit the dredge at some point and passed over the dredge frame. When all five carcasses were examined for injuries, the only observed carcass damage was superficial scratches and chips (Figure 4). None of the damage observed on the five recovered carcasses was consistent with a category I or category II injury (NMFS 2004).
